INSPECTION REPORT

For the Property at:
123 ANYWHERE STREET
BRANTFORD, ON

Prepared for: CLIENT NAME
Inspection Date: Saturday, February 3, 2007
Prepared by: Brandon McLaughlin

McLaughlin Property Inspection Inc.
46 Sudds Lane
Brantford, ON N3T 6N2
519-720-8674

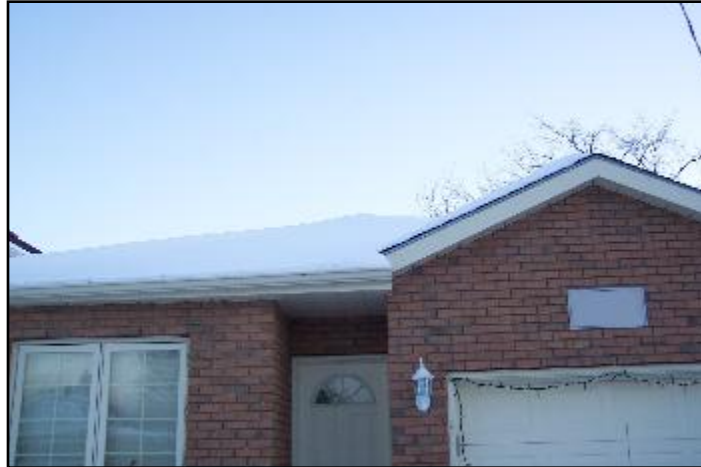
Note: Roof inspection was severely limited. Snow and/or ice covered the entire roof surface. Snow was brushed from several location at eave level. Shingles appeared to be of normal age/wear at these locations.

Snow Covered Roof

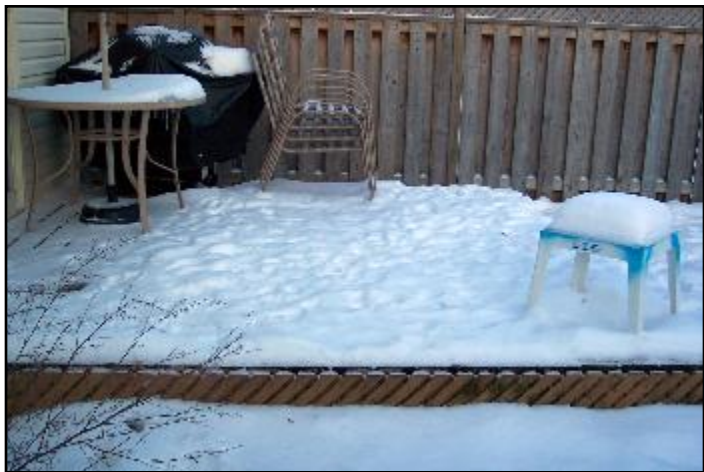
Note: The attached deck at the rear of the property is close to the ground. The underside of the deck is enclosed with lattice which prevented inspection.

Attached Deck

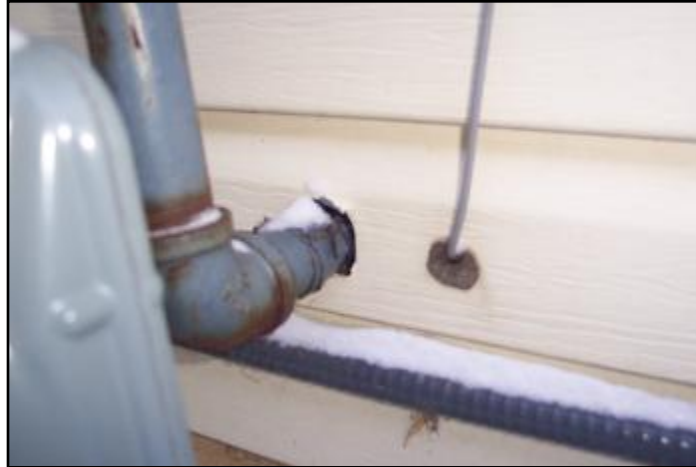
Condition: • [Caulking missing or ineffective](#)

Note: Caulking required at gas line entry to building.

Caulking Required at Gas Line Entry

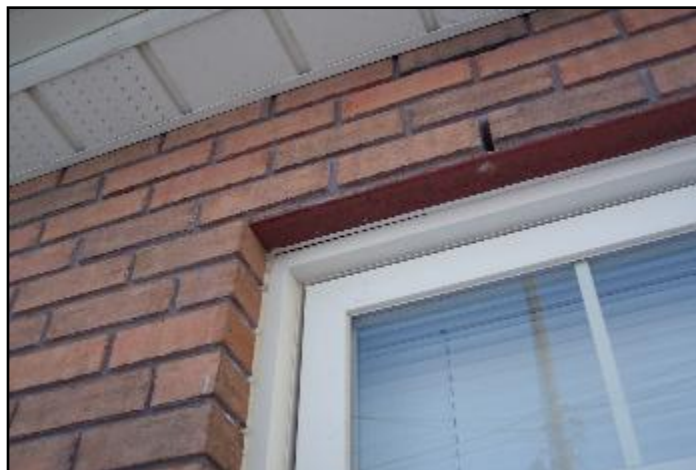
Condition: • [Lintel rusting](#)

Note: Minor rust perforation is visible on the underside of the lintel. The rust should be cleaned from the surface of the steel and a rust resistant topcoat applied to prevent further deterioration.

Surface Rust on Lintel and Caulking Required

Condition: • [Caulking missing, loose or deteriorated](#)

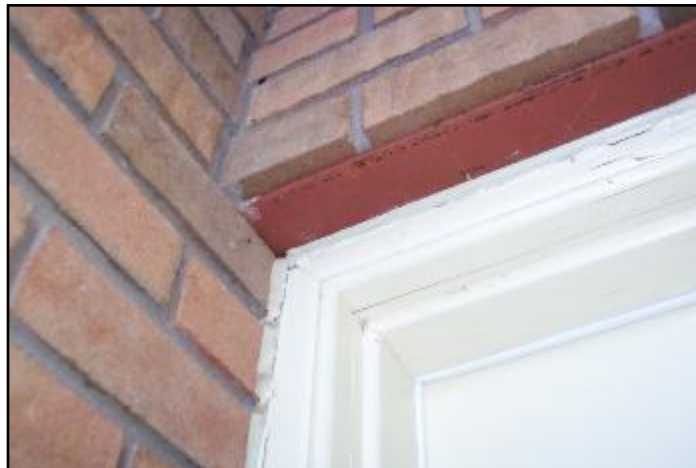
Condition: • [Caulking missing, deteriorated or loose](#)

Note: Minor rust perforation is also visible on the underside of the lintel at the front door. The rust should be cleaned from the surface of the steel and a rust resistant topcoat applied to prevent further deterioration.

Deteriorated Caulking and Minor Rust

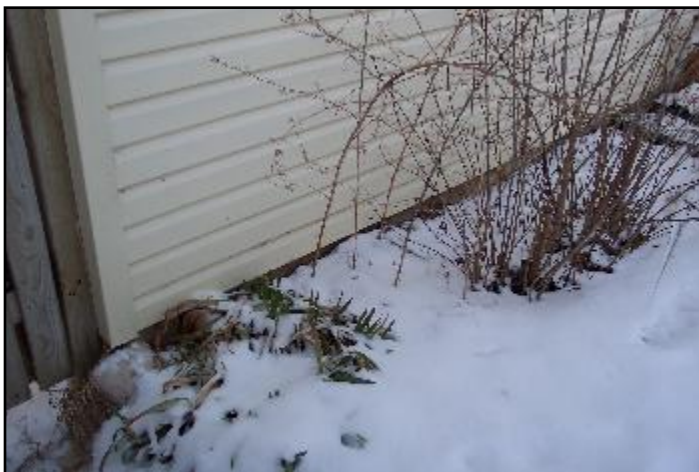
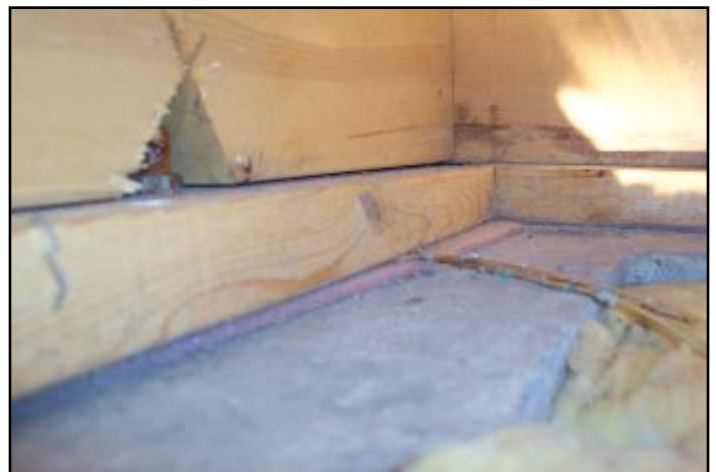
Condition: • [Planters and gardens against walls](#)

Note: Vegetation roots were visible on the interior of the house, in the basement, between the sill plate and sill gasket. Removal of vegetation or reduction in garden height to 6" clear distance between top of vegetation and bottom of vinyl siding is highly recommended. Removal of roots found at the interior should be performed immediately as moisture could be drawn into the basement.

Evidence of active moisture was not visible in this area at the time of inspection.

Garden at rear yard

Same location, viewed from basement

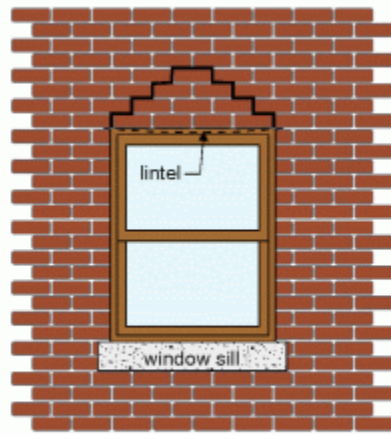
crack pattern commonly associated with sagging lintels due to undersizing or deterioration

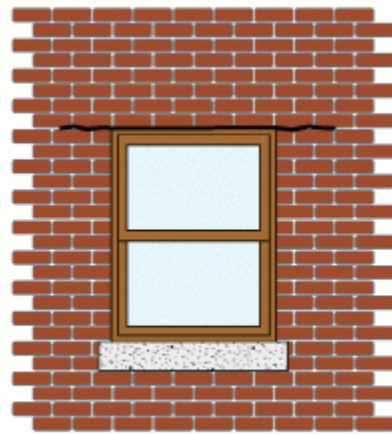
horizontal crack often caused by rusting steel lintels expanding

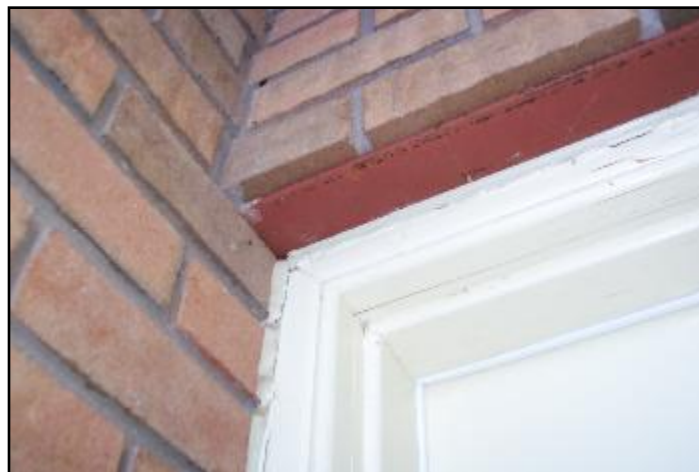
Condition: • [Rust](#)

Note: Minor rust perforation is visible on the underside of the lintels. The rust should be cleaned from the surface of the steel and a rust resistant topcoat applied to prevent further deterioration.

Surface Rust on Underside of Lintel

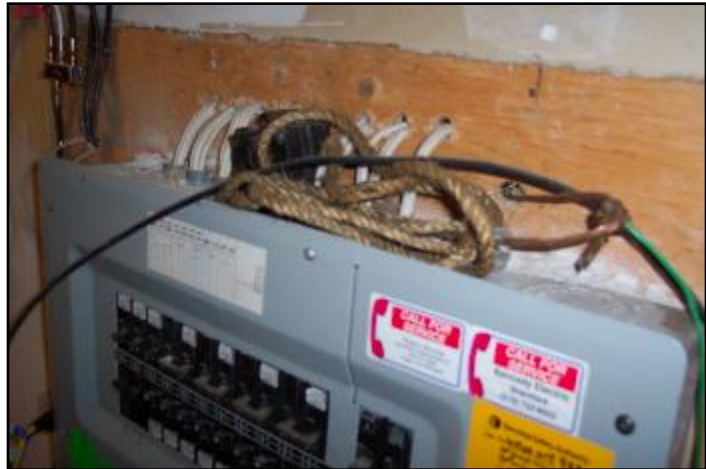
Condition: • Combustible items stored on top of Panel

Implication(s): Fire could be started should an electrical short circuit occur.

Items stored on Panel

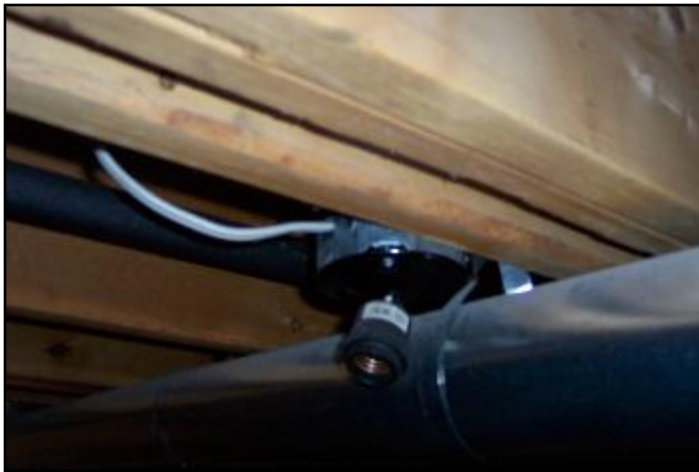
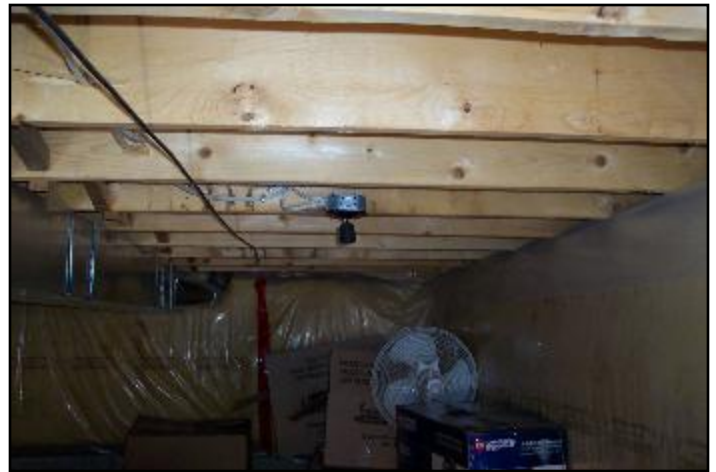
Condition: • [Missing](#)

Missing Light

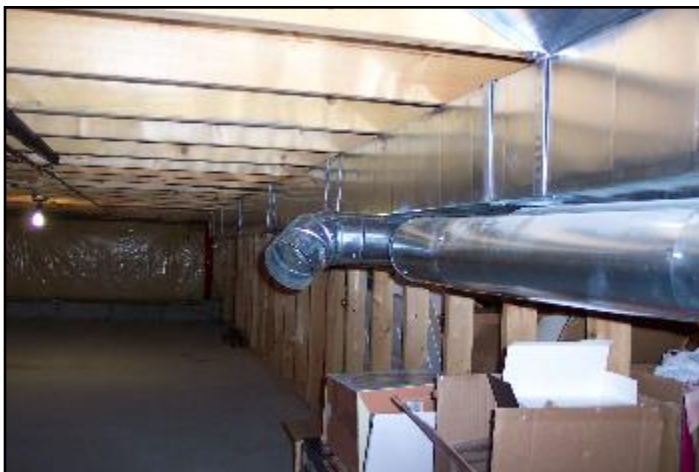
Condition: • [Disconnected ducts](#)

Note: The duct servicing the kitchen has been disconnected in the crawl space. Cold spots could be more prominent in the kitchen due to this condition.

Duct Disconnected at Trunk

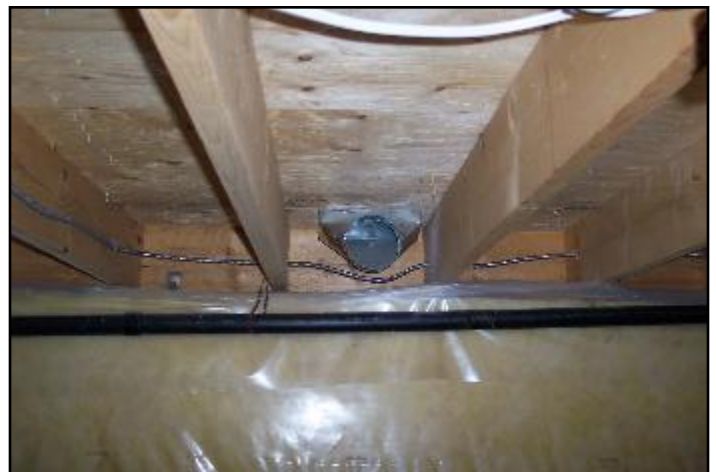
Duct Disconnected at Register

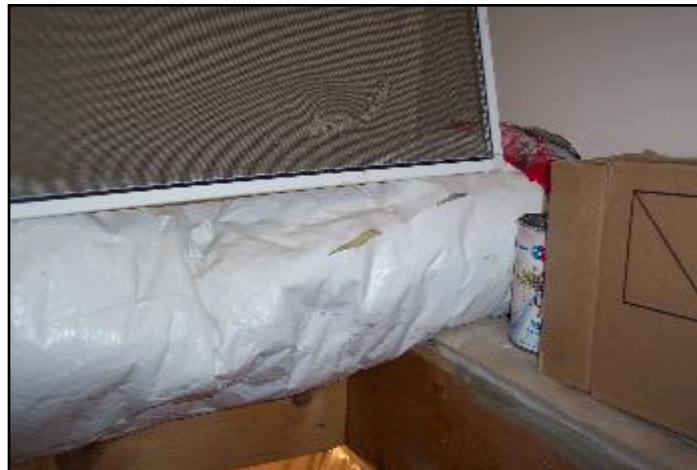
Condition: • [Insulation missing, damaged](#)

Note: Vapour barrier portion of duct insulation is sliced. Recommend taping cut areas with approved vapour barrier tape (tuck-tape).

Cuts in Duct Insulation

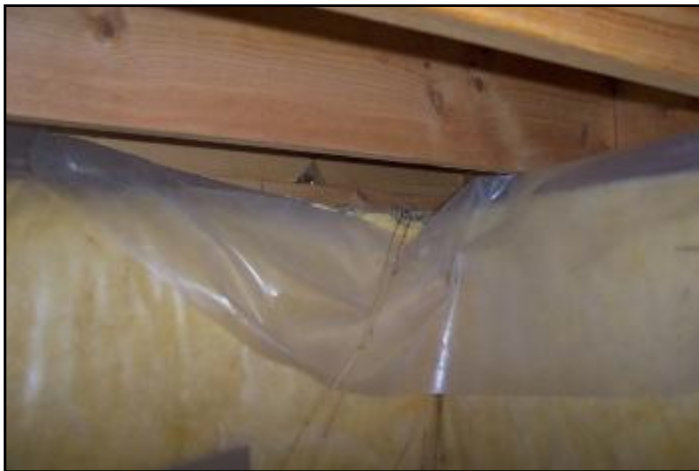
Condition: • [No vapor barrier](#)

Note: The vapour barrier has been compromised as it is pulled down at two (2) locations in the crawl space. The vapour barrier can be repaired by lifting it back into place and securing it to the sill plate as in the remainder of the crawl space.

Vapor Barrier Compromised - Right Rear

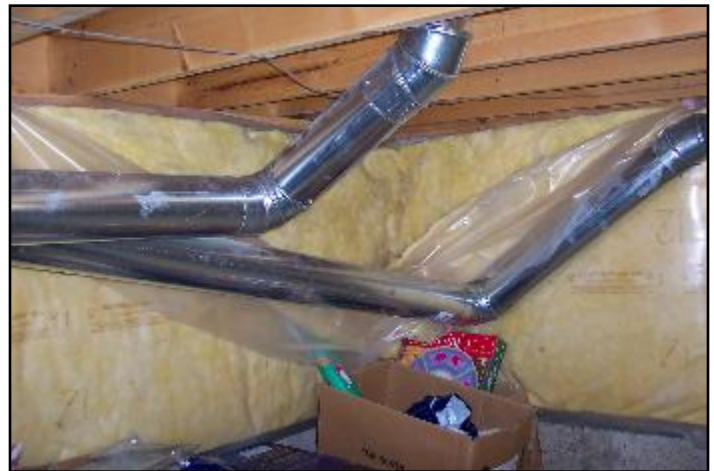
Vapor Barrier Compromised - Front Middle

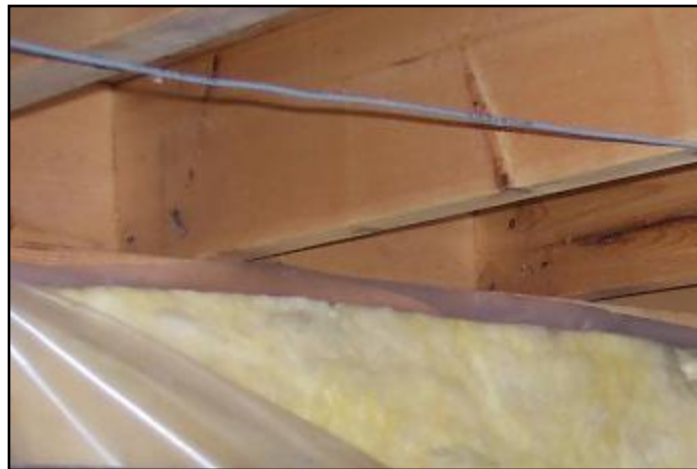
Condition: • [None at rim joist](#)

Note: The insulation and vapour barrier stop at the top of the foundation wall. Insulation and vapour barrier should be continued into header/rim joist cavity for improved heating efficiency.

Insulation Stops at Top of Foundation Wall

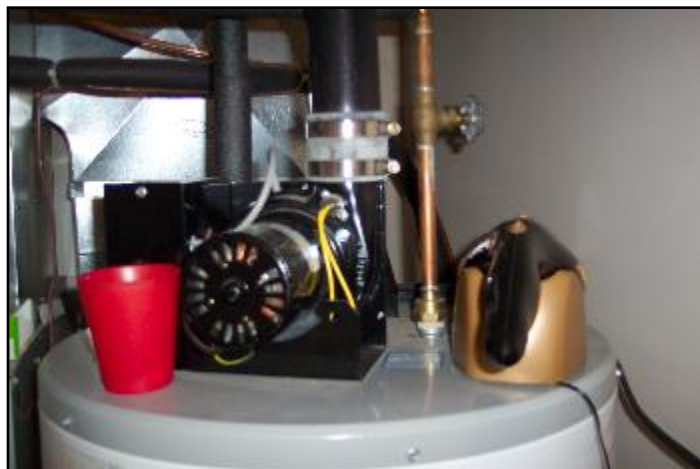
• Minimum Clearance to Combustible Items

Implication(s): Fire could occur at water heater. Minimum clearances are identified on water heater safety label and should be followed.

Items Stored on Water Heater

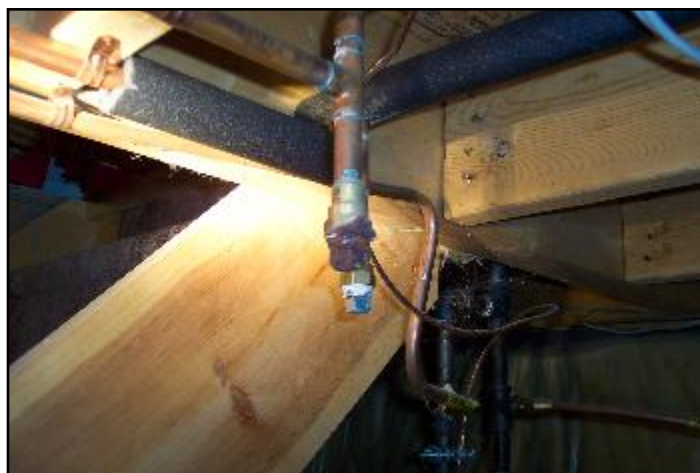
Condition: • [Rust](#)

Note: Rust on screw-in style steel plug could begin to leak at any time. Recommend replacing with copper plug or soldered end cap.

Rust on Plumbing Plug

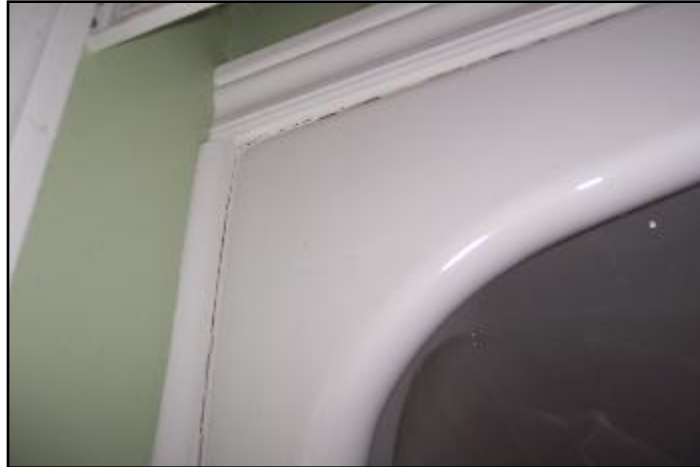
Condition: • [Caulking loose, missing or deteriorated](#)

Caulking Deteriorated

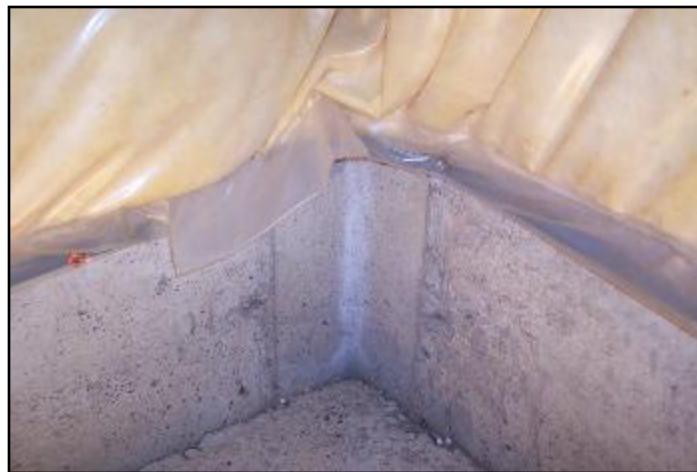
Efflorescence at Front Left Corner

Condition: • [Efflorescence](#)

Note: This is evidence that moisture has occurred. There was no evidence of active moisture present at the time of inspection. No efflorescence or staining was observed on the floor or surrounding area. This item should be monitored for severity and number of occurrences.

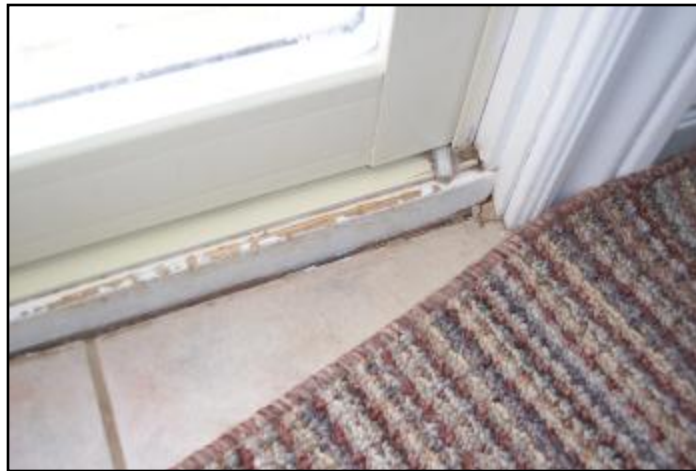
Condition: • [Grout missing](#)

Note: The ceramic area at sliding door entrance to rear yard was missing grout at the joint adjacent to sliding door track. Recommend repair with caulking as expansion and contraction of different materials would continue to crack grout.

Grout Missing at Sliding Door Entrance

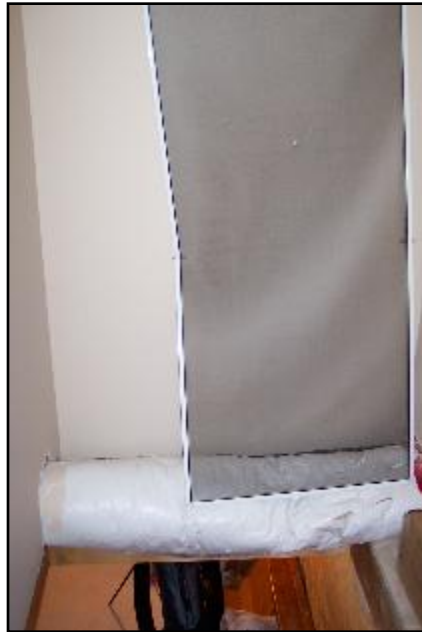
Condition: • [Missing](#)

Note: Screens were torn or missing at various locations. Some screens were found in crawl space and crawl space entrance.

Screen Found at Crawl Space Entrance

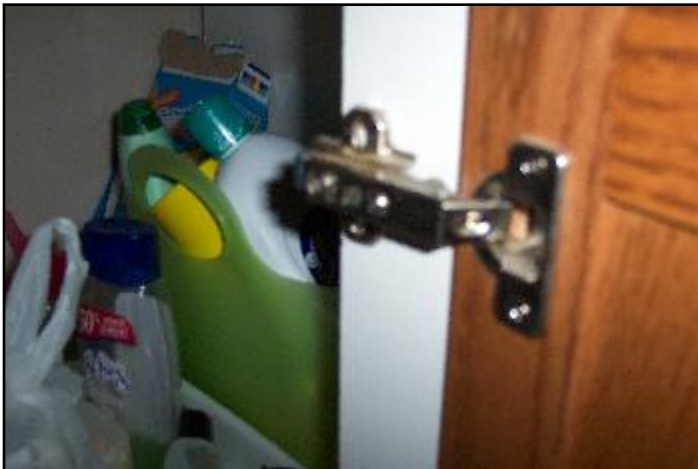
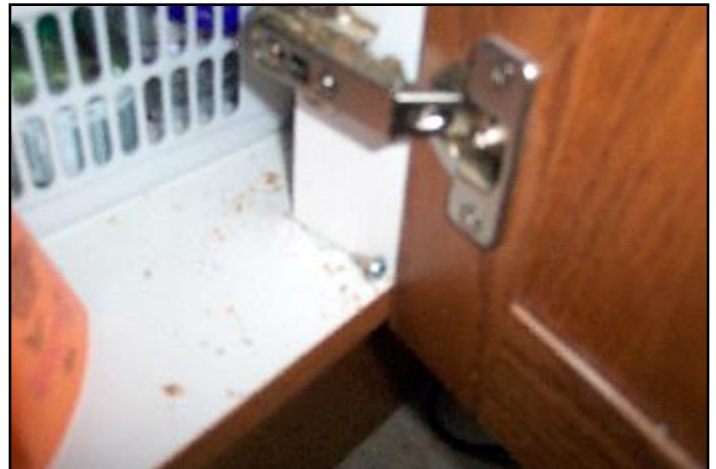
Condition: • [Doors or drawers missing or loose](#)

Note: The door hinges of the bathroom cabinet were found to be loose and had screws missing. These items should be repaired immediately to avoid significant cost of replacement.

Hinge - Screw Missing

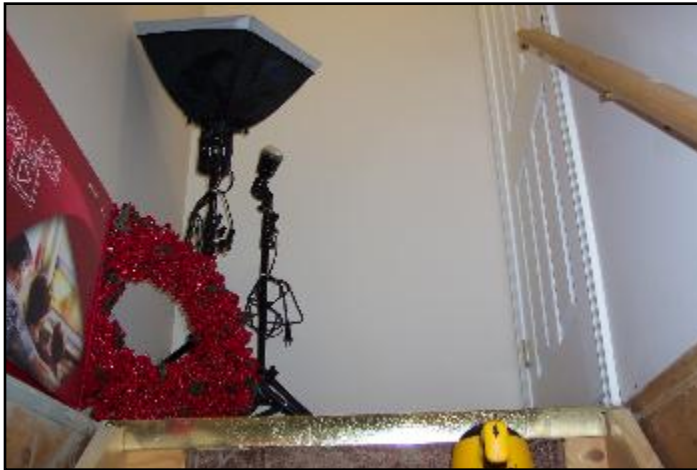
Condition: • Items Stored on Landings

Implication(s): Safety - Trip Hazard

Trip Hazard at Top of Crawl Space Stair

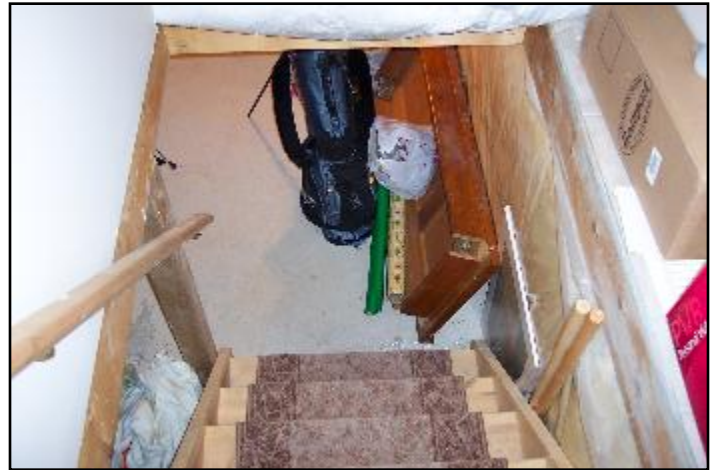
Trip Hazard at Bottom of Crawl Space Stair
