INSPECTION REPORT

For the Property at:
123 ANYWHERE STREET
BRANTFORD, ON

Prepared for: CLIENT NAME
Inspection Date: Saturday, February 3, 2007
Prepared by: Brandon McLaughlin

McLaughlin Property Inspection Inc.
46 Sudds Lane
Brantford, ON N3T 6N2
519-720-8674

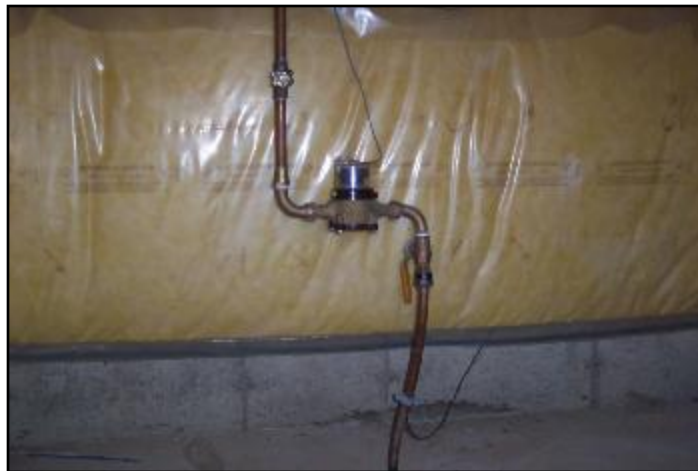
Water Meter and Shut Off Location

Note: The water meter is located in the crawl space at the front of the house. A remote meter reading receptacle is attached. Water shut off is available on both the street-side and house-side of the meter.
